**DRAFT REPORT**

**BIRCH BAY SHORELINE IMPROVEMENT  
PLAN AND CONCEPTUAL DESIGN**

Whatcom County Council of Governments

November 21, 2002

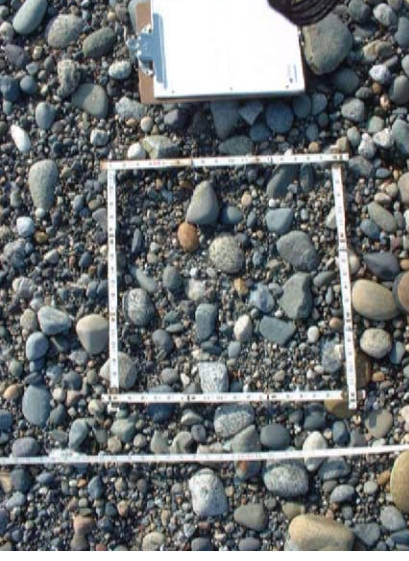
*figure 4*

a. Intersection of the beach face and low tide terrace

b. Lower Beach Face

c. Upper Beach Face

d. Berm Crest
